## **The Use of LS-DYNA in the Columbia Accident Investigation and Return to Flight Activities**

Jonathan Gabrys & Josh Schatz  
*The Boeing Company*  
*Philadelphia, PA*

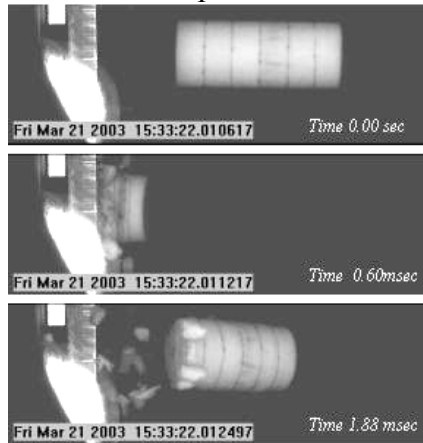
One of the impact tests that were performed consisted of shooting a foam cylinder, 3.00 inches in length and 1.25 inches in diameter, at a target mounted on load cells. Figure 2 shows the foam at several times during the impact event. The foam actually compresses from 3.00 inches to 0.50 inches and then returns to its original length. This specific set-up allowed for load time history data to be measured. The test set-up was modeled and the impact event simulated in an effort to create material properties of the foam. Figure 3 shows the FEM of the test set-up and figure 4 shows the comparison between the measure impact data with the predicted impact data. Since the data was filtered at 2400 Hz, getting an exact comparison was not possible. However, the predicted data, also filtered, does show good correlation, although slightly conservative. Please refer to "Material Modeling of Space Shuttle Leading Edge and External Tank Materials

Figure 2. Time snap-shots of a foam impact test

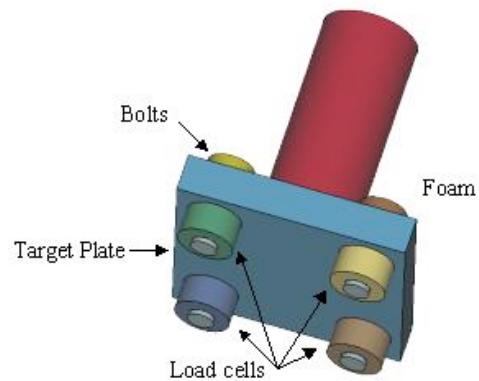
Figure 3. FEM of the test set-up

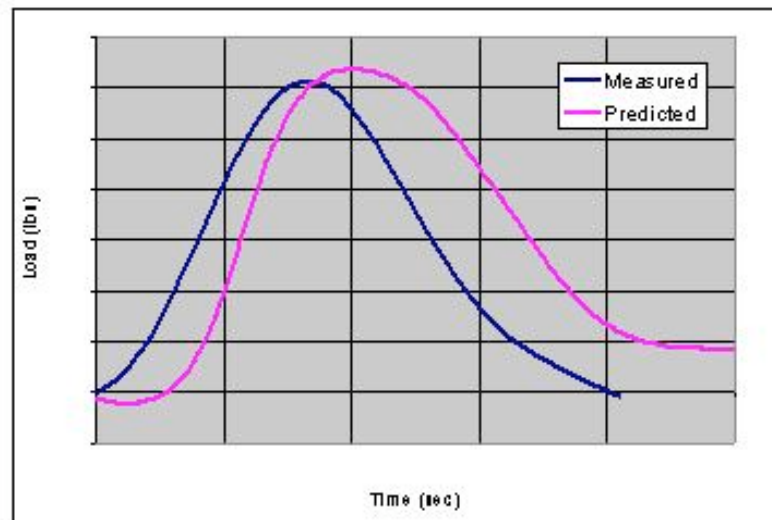
Figure 4. Comparison between the measure impact data with the predicted impact data

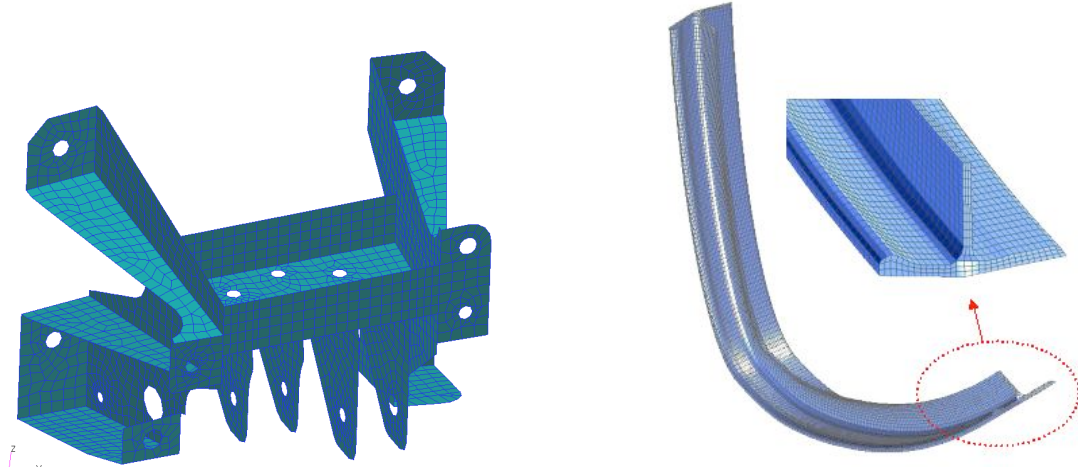
Figure 5. Meshed geometry (left: Lug; right: T-seal)

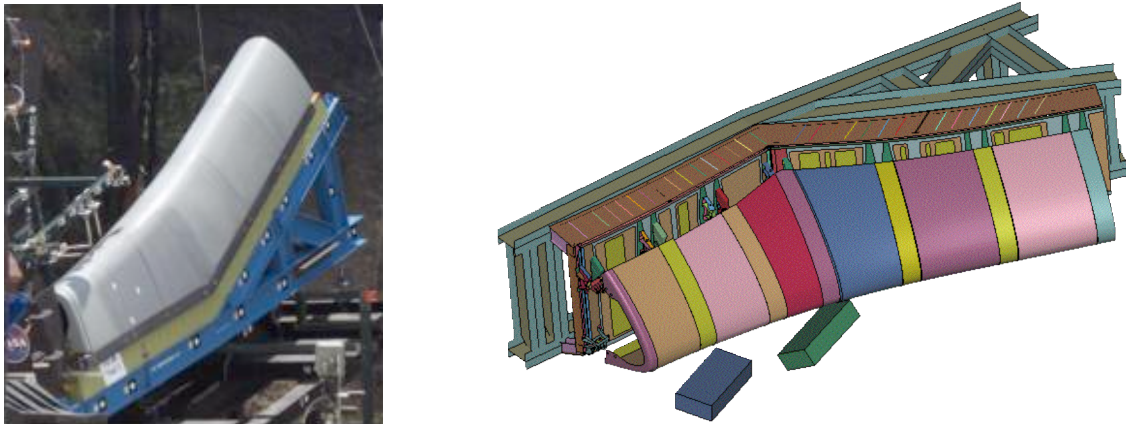
Figure 6. Comparison of test set-up and FEM (various foam orientations shown)

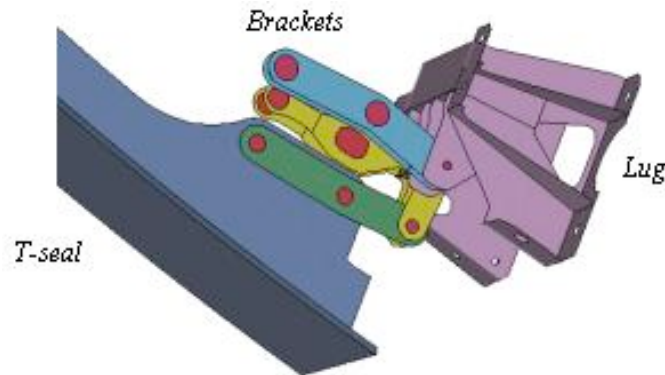
Figure 7. Picture of a modeled joint: rigid materials that fill the fastener holes are used to create revolute joints between brackets, lug, and T-seal (other brackets shown used for adjacent panels)

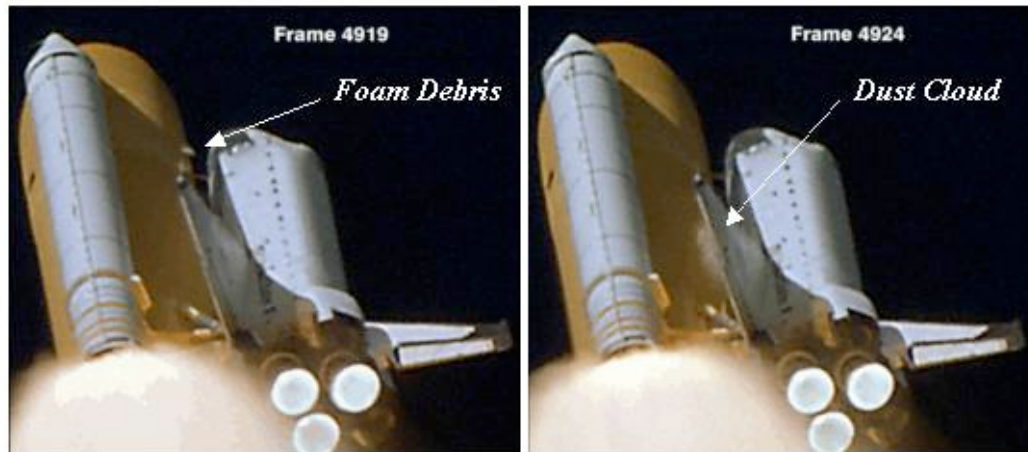
Reviewing the pictures of the foam impact event, it appeared that a thick dust cloud was generated as a result of the impact event, see figure 8. This observation, along with the estimated foam size and impact speed, was used for the initial set of impact analyses. To simulate the thick dust cloud, the foam was initially modeled using Eulerian elements along with an equation of state. Eulerian elements, unlike Lagrangian elements, do not deform (LS-DYNA does allow the user to control the deformation), but allow the mass to move between elements. Thus Eulerian elements do not get 'skewed', which would reduce time step. It also enables the analysis to accurately predict large non-linear behavior or 'splattering' events. Results from the initial set of analyses are shown in figure 9.

Figure 8. Time snap-shots showing the impact event

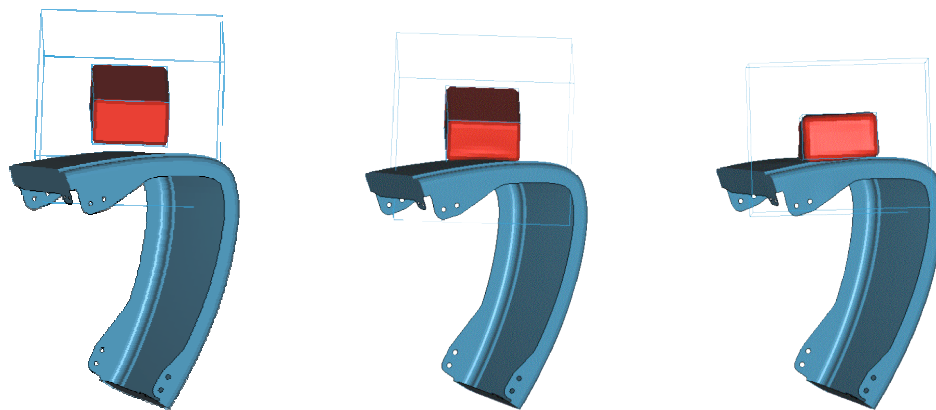
As the foam testing and material model development progressed, the foam was modeled using Lagrangian elements with elastic material properties. Although using elastic material properties was not completely accurate, it was more accurate than the initial approach using a fluid-like behavior. Results with the new foam material model were noticeable different, see figure 10.

Figure 10. Simulation of a foam impact event using Eulerian Elements and elastic material properties to represent the foam

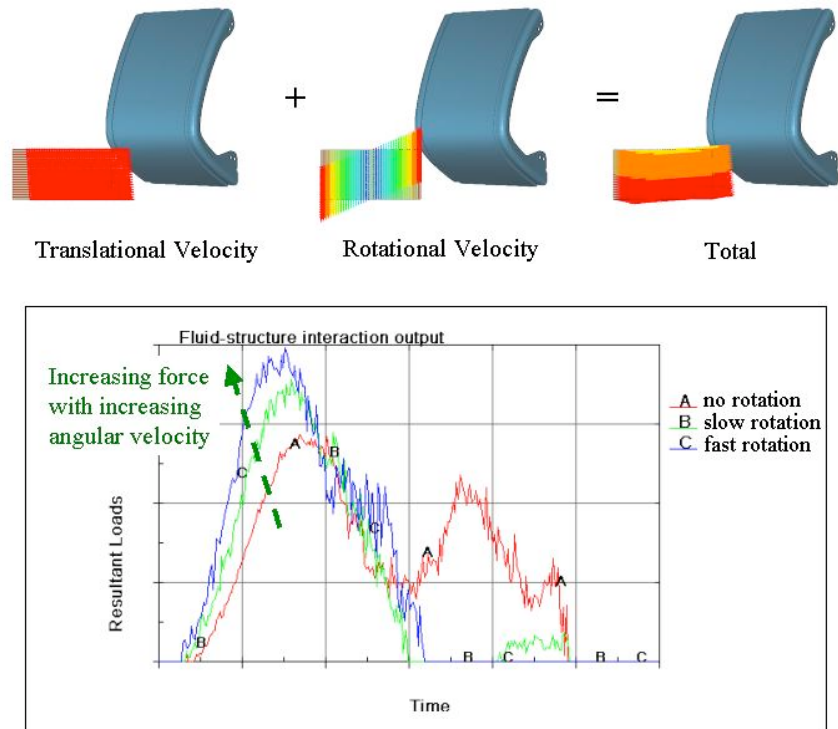
Video footage of the impact event shows the foam both translating and rotating. However, the tests being performed at Southwest Research Institute were only translating the foam and there was some concern that these tests would not be reproducing the actual event. Our next task was to understand the importance of foam rotation on impact load. To provide some insight, 3 different cases were analyzed: no rotation, slow rotation, and fast rotation. Results from the analyses, figure 11, show that the rotation did have a noticeable influence on the resulting load.

Figure 11. Effects of foam rotation investigated

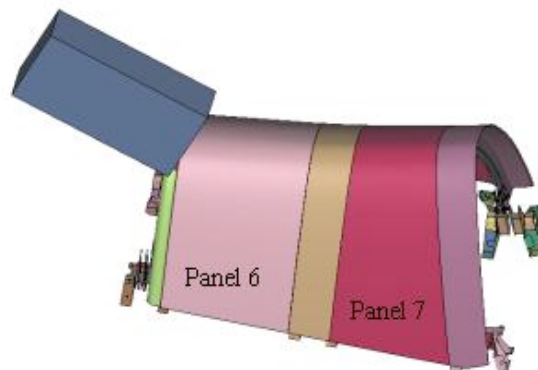
As more of the finite element model was developed, larger models were used in the impact analysis. One such analysis consisted of Panels 6 & 7, T-seal 7 & 8, and supporting substructure. This specific configuration was chosen because it represented a concurrent test. Results from the test were used to validate the model. Figure 11 shows the finite element model used. A detailed comparison between the test and the analytical simulation was performed by NASA Langley [6,7].

Figure 11. FEM used for the panel 6-impact analysis
